Historic Structure Report
Main House and Annex
Scotty's Castle, Death Valley Ranch

HISTORIC STRUCTURE REPORT
DEATH VALLEY SCOTTY HISTORIC DISTRICT
MAIN HOUSE AND ANNEX

September 1991

UNITED STATES DEPARTMENT OF THE INTERIOR / NATIONAL PARK SERVICE

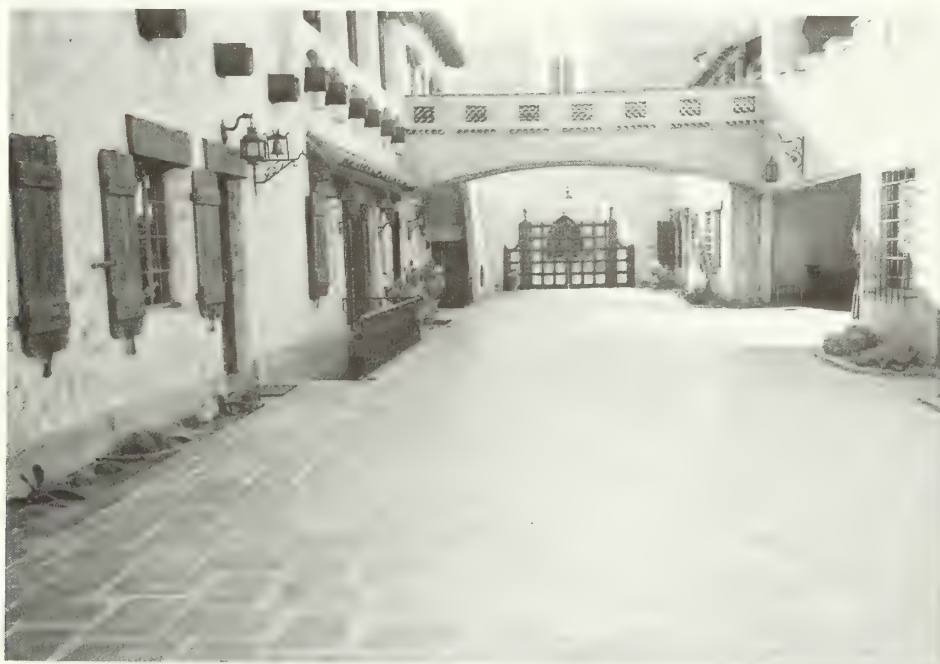
Photo 1: Patio, looking west.

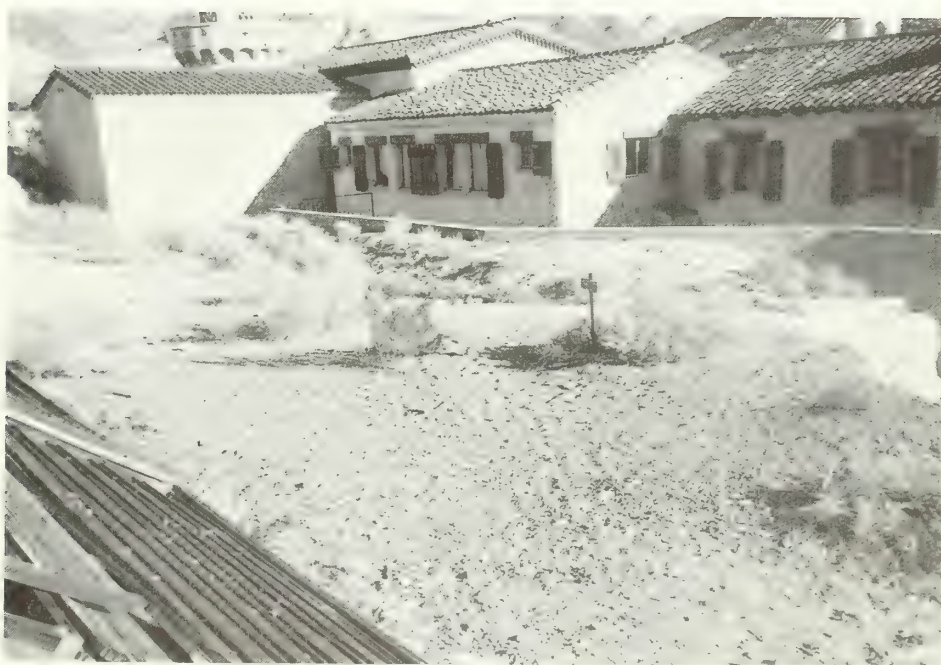
Photo 2: Hillside, looking southeast.

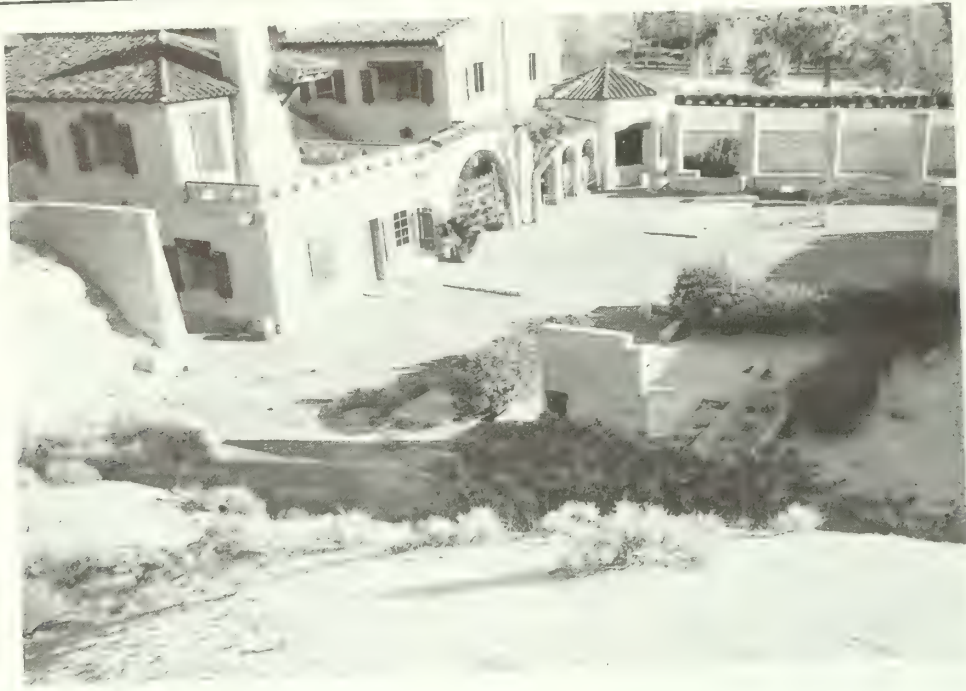
Photo 3: Area to west of castle, looking south.

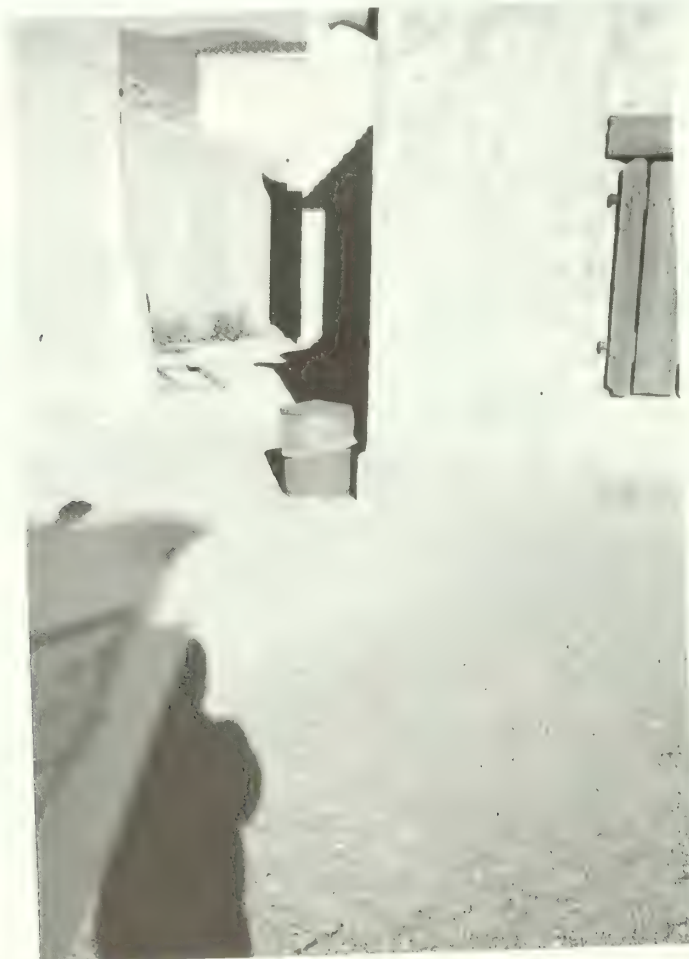
Photo 4: Northwest corner of annex, looking east.

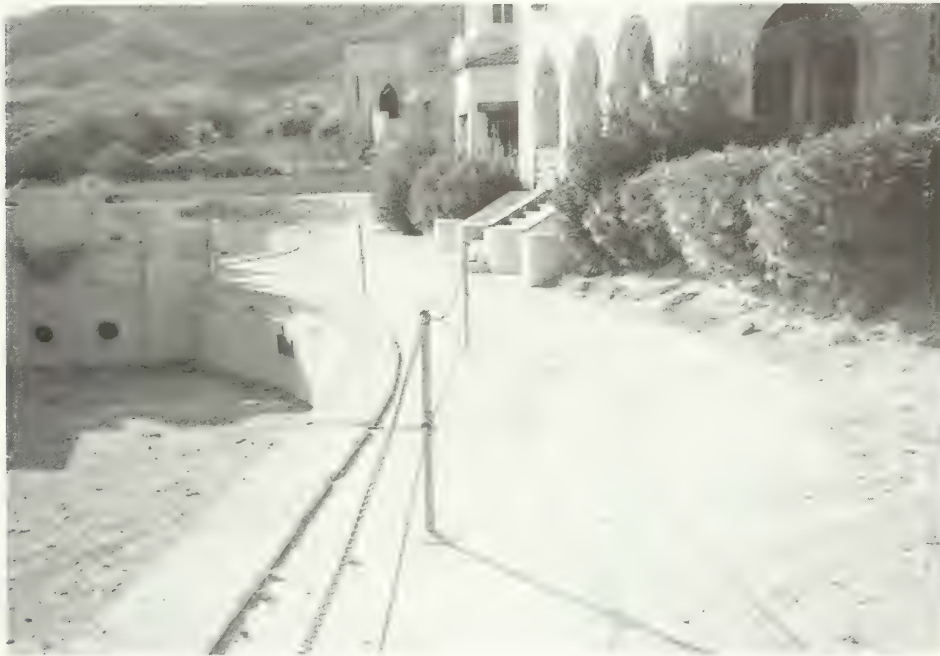
Photo 5: Swimming pool area, looking west.

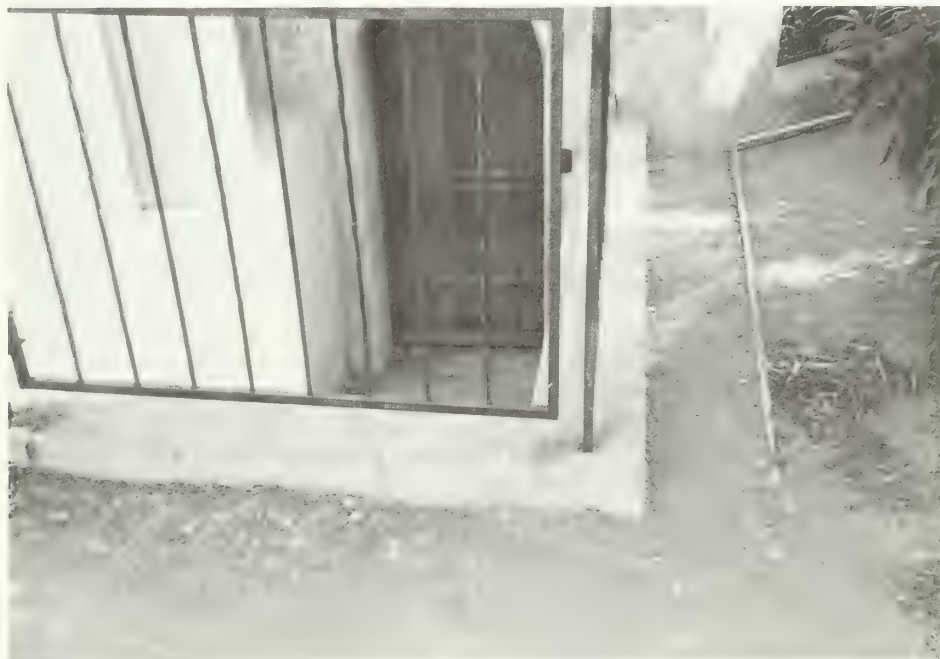
Photo 6: Door at southwest corner of main house.

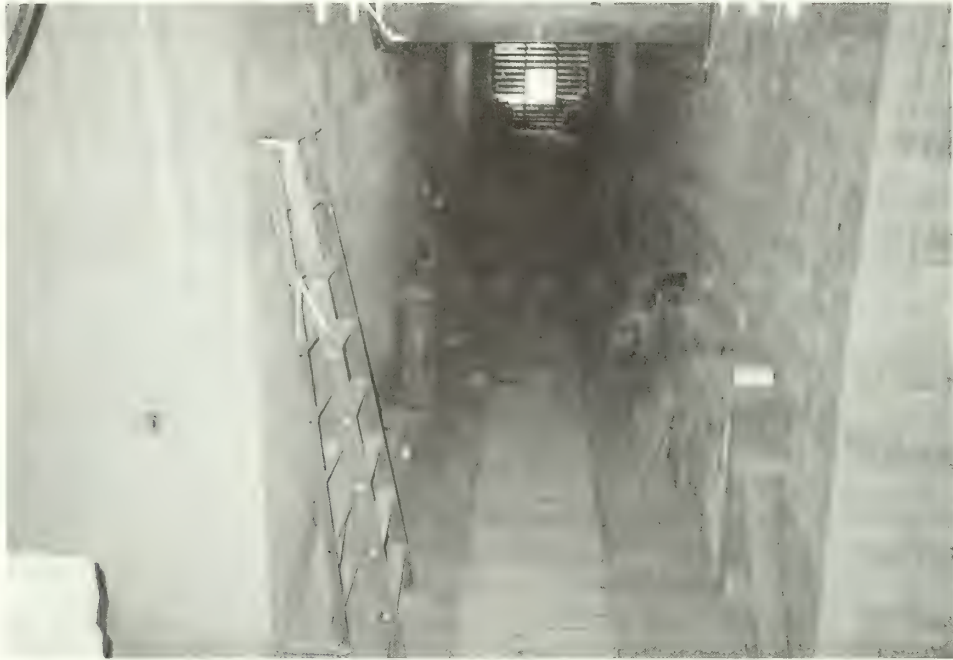
Photo 7: Tunnel under swimming pool, looking south.

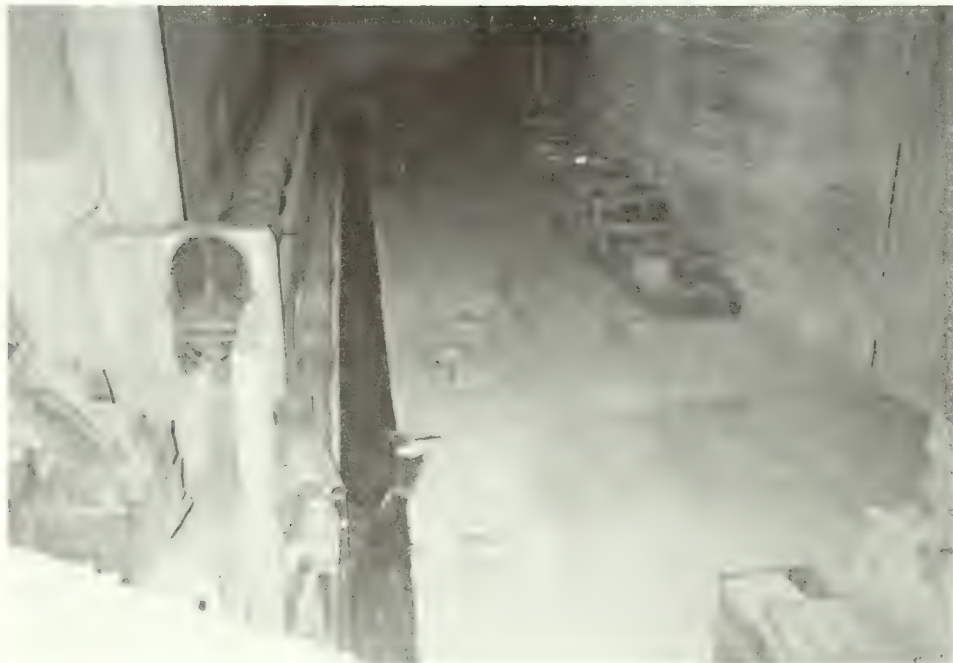
Photo 8: Tunnel between main house and swimming pool, looking east.

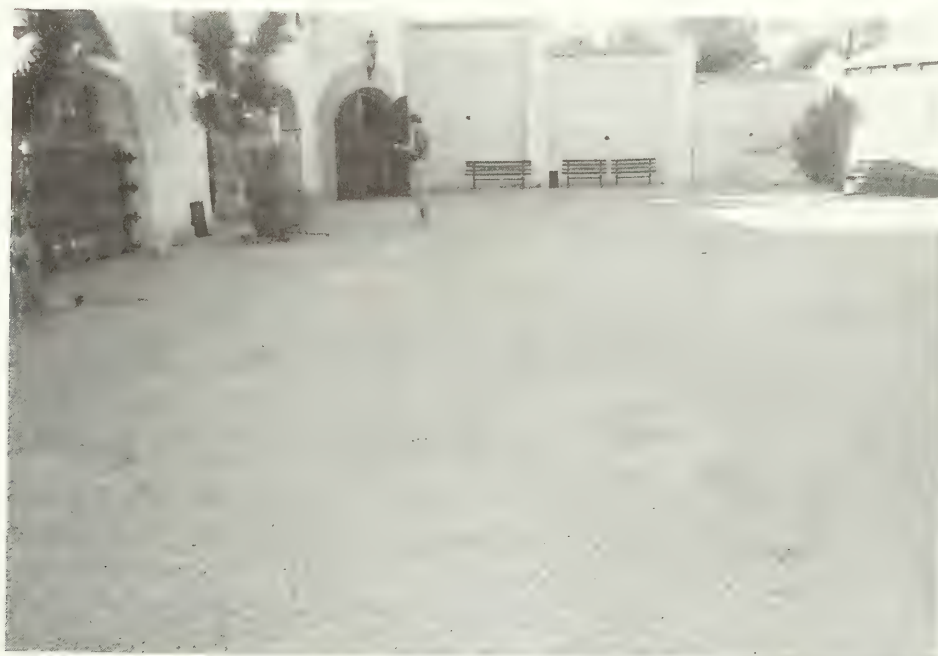
Photo 9: Paved area, looking north.

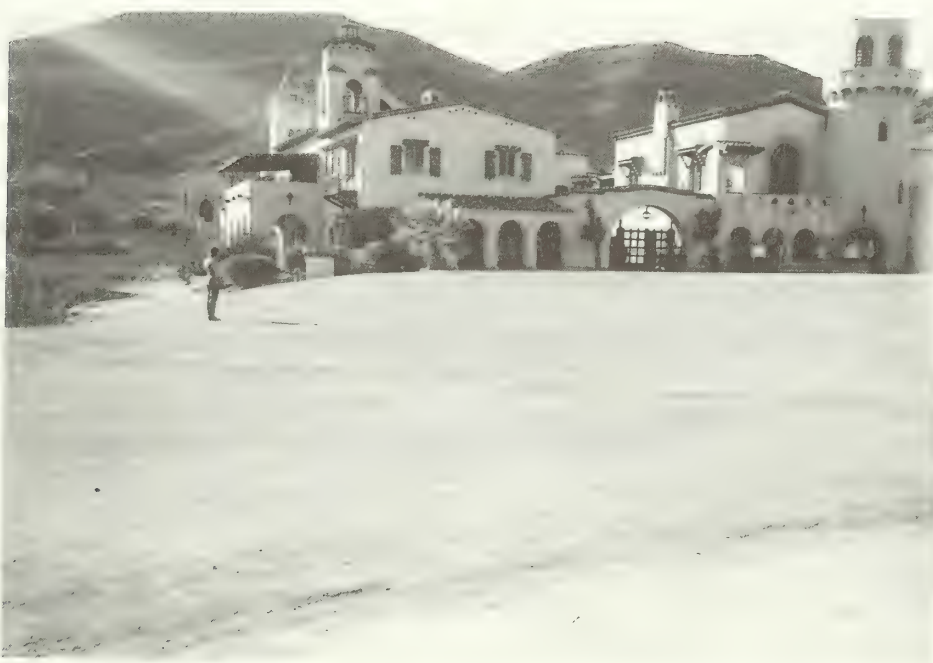
Photo 10: Paved area, looking west.

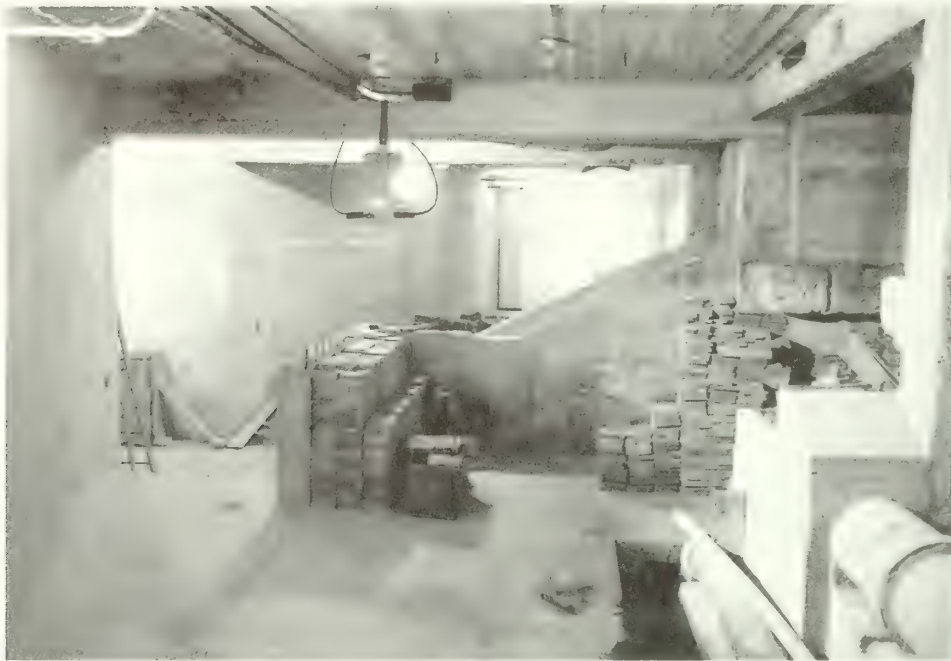
Photo 1: Tunnel between Main House and swimming pool. (Photo by D. Snow)⁵⁹

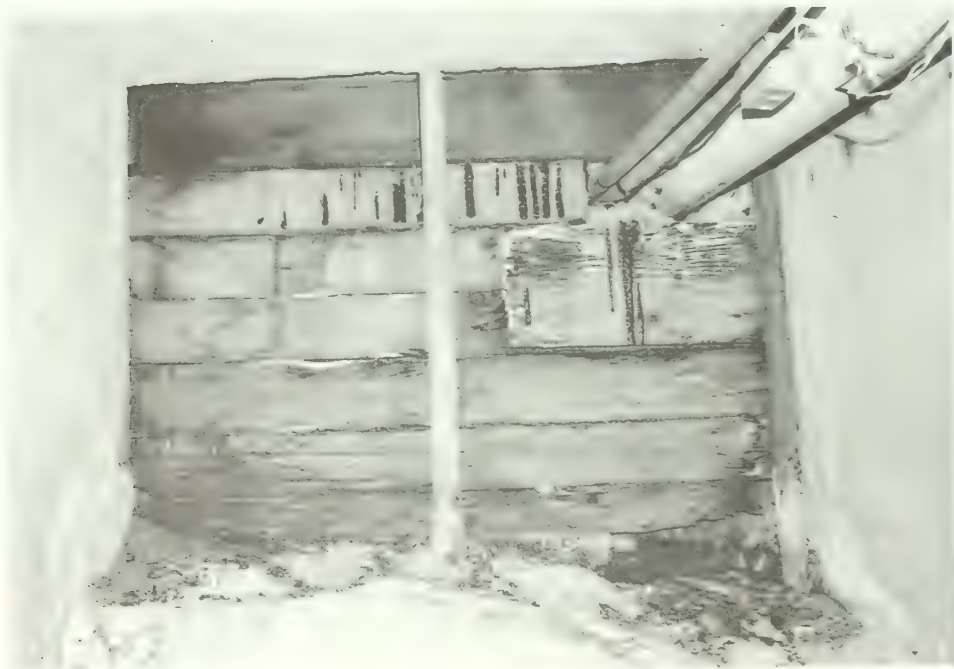
Photo 6: Timber bulkhead. Located at the east end of the tunnel adjacent to the swimming pool (location "U"). (Photo by R. Silva)

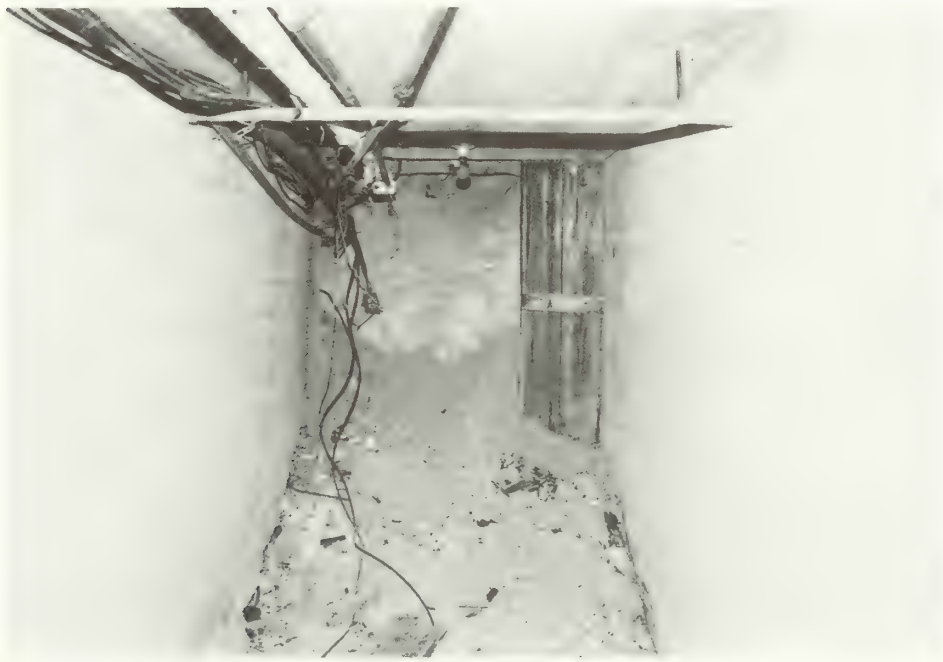
Photo 7: End of tunnel at Hacienda (location "A"). (Photo by R. Silva)

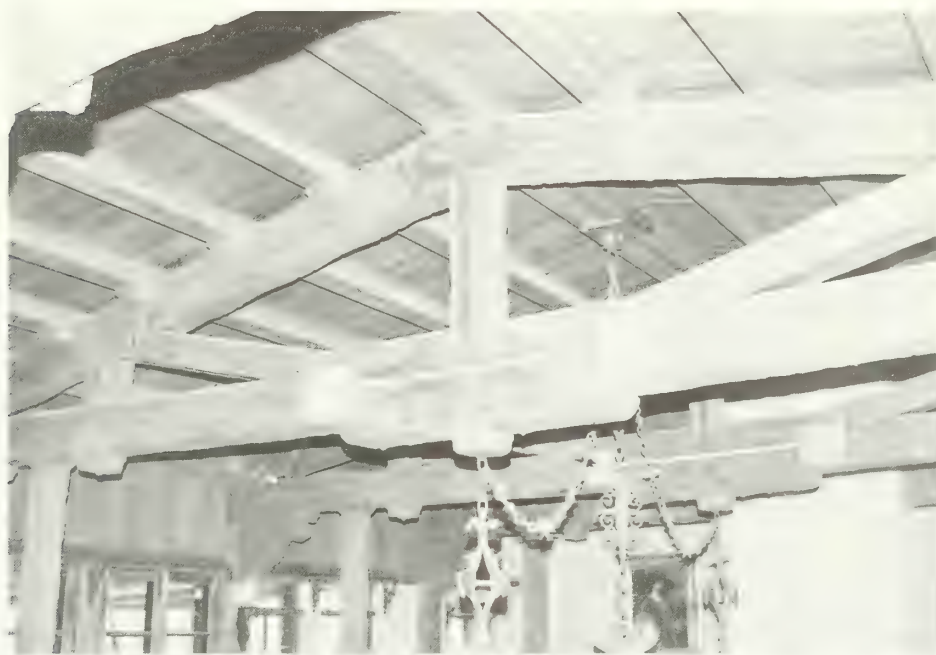
Photo 11: Great Hall trusses. Shows the tension anchors added in the 1970s. (Photo by R. Silva.)

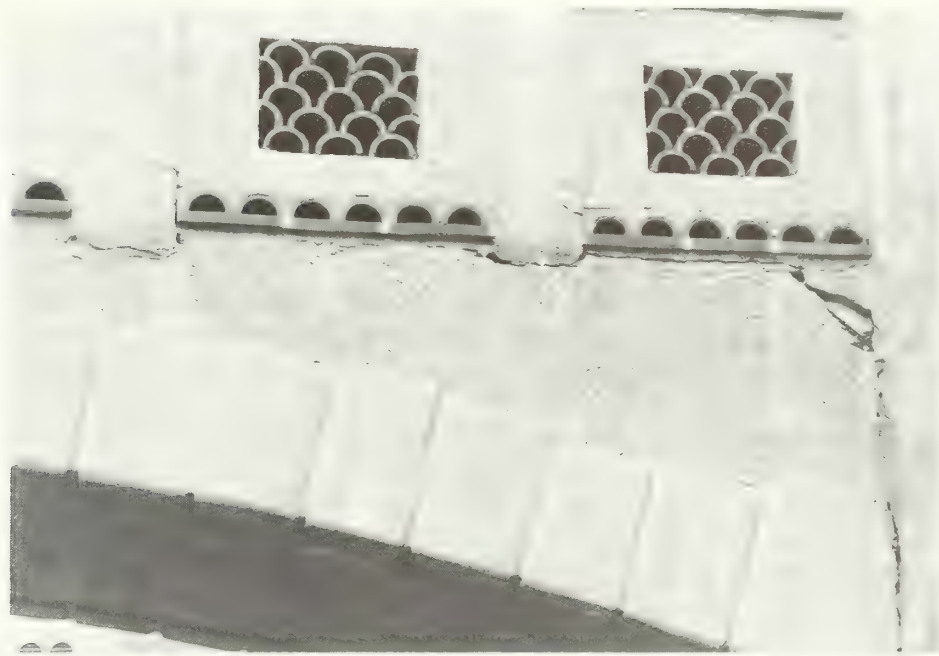
Photo 15: Bridge to Annex junction. East side of bridge, showing crack and spalled stucco at junction and stucco cracks along bridge deck level and in railing. (Photo by R. Silva)

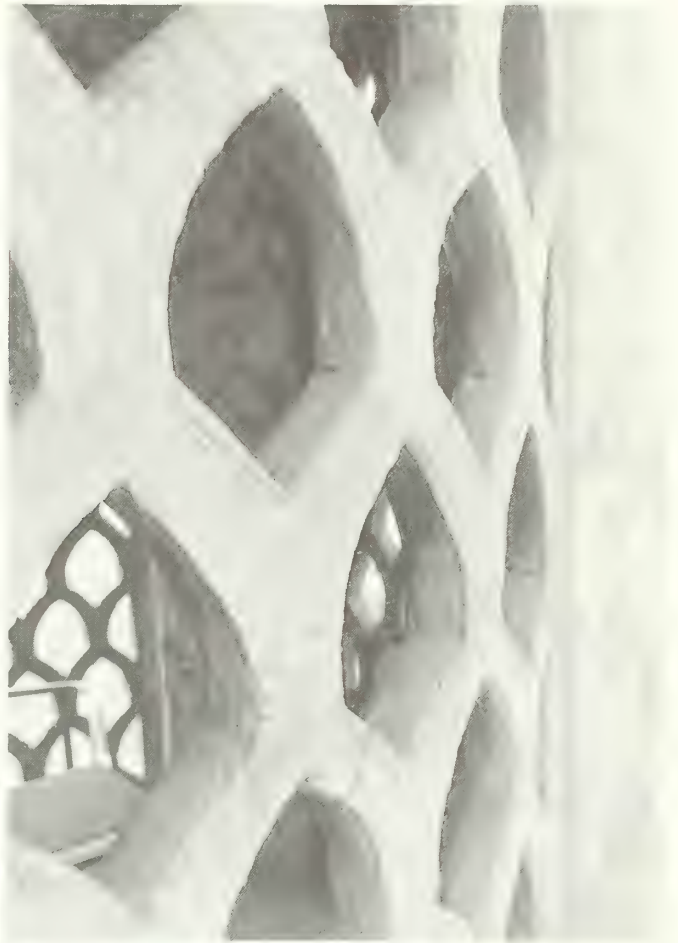
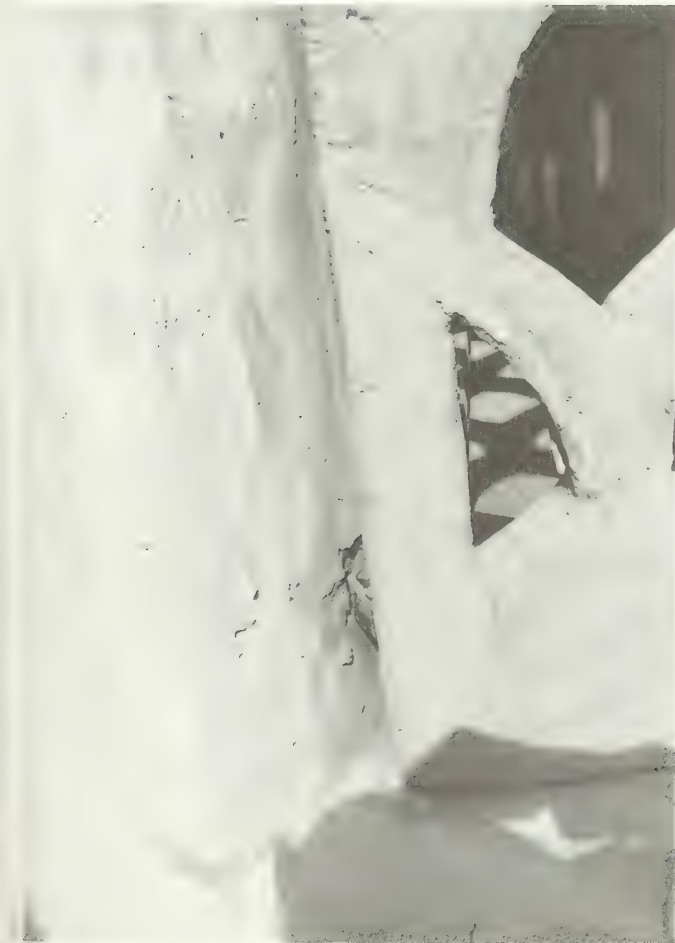
Photo 2: Annex Tower, detail of hinge connection.

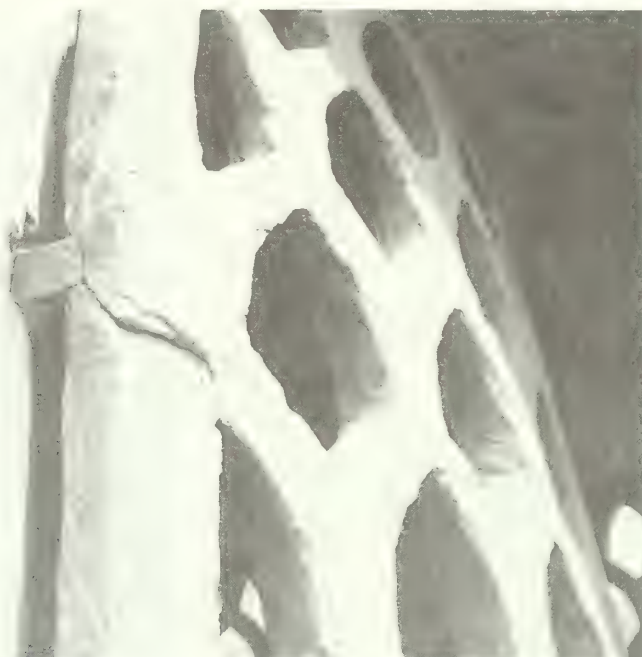
Photo 3: Annex Tower, detail of damaged hinge connection.

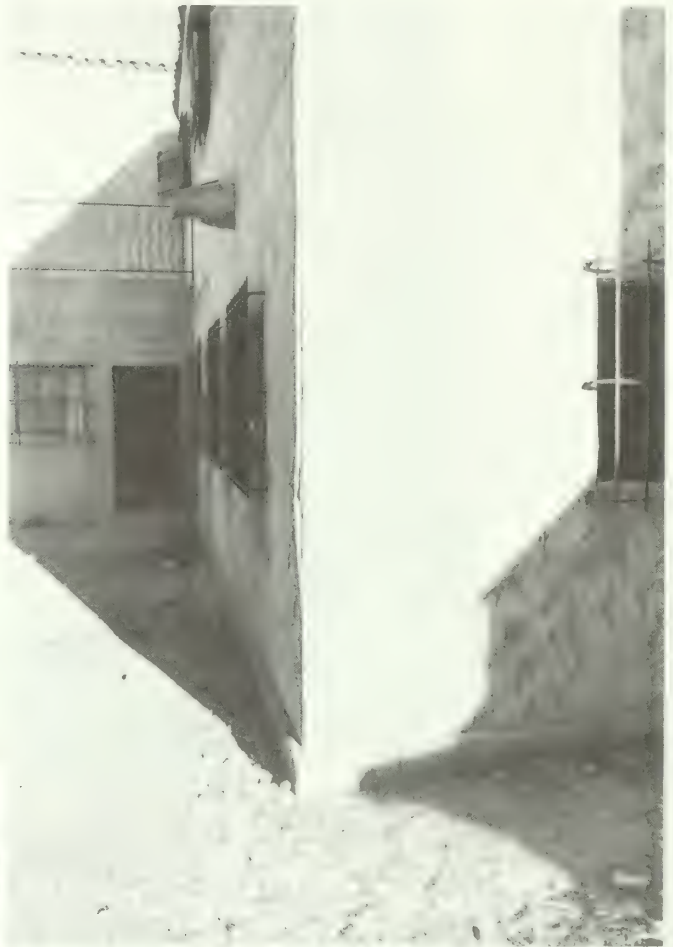
Photo 7: Annex north wall, northwest corner. Note stucco failure at corner.

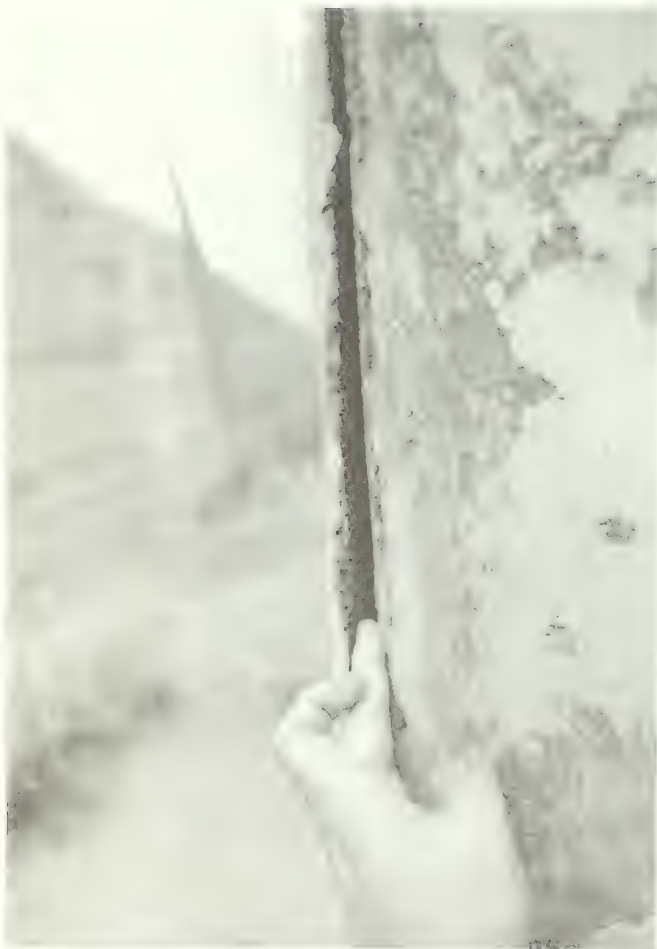
Photo 8: Close-up of northwest corner illustrated in photo 7.

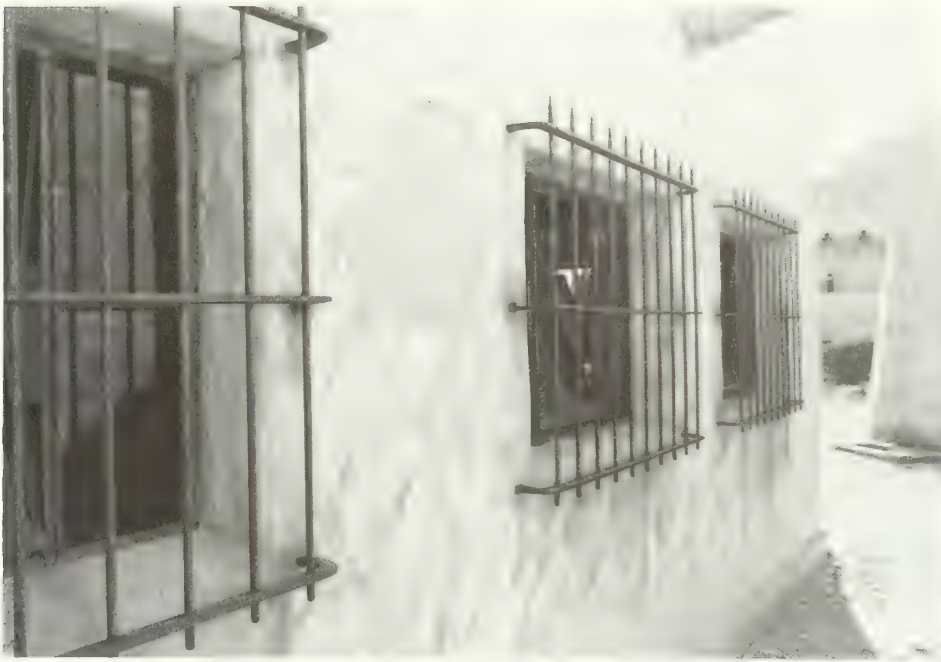
Photo 9: Annex north wall. Note loss of stucco.

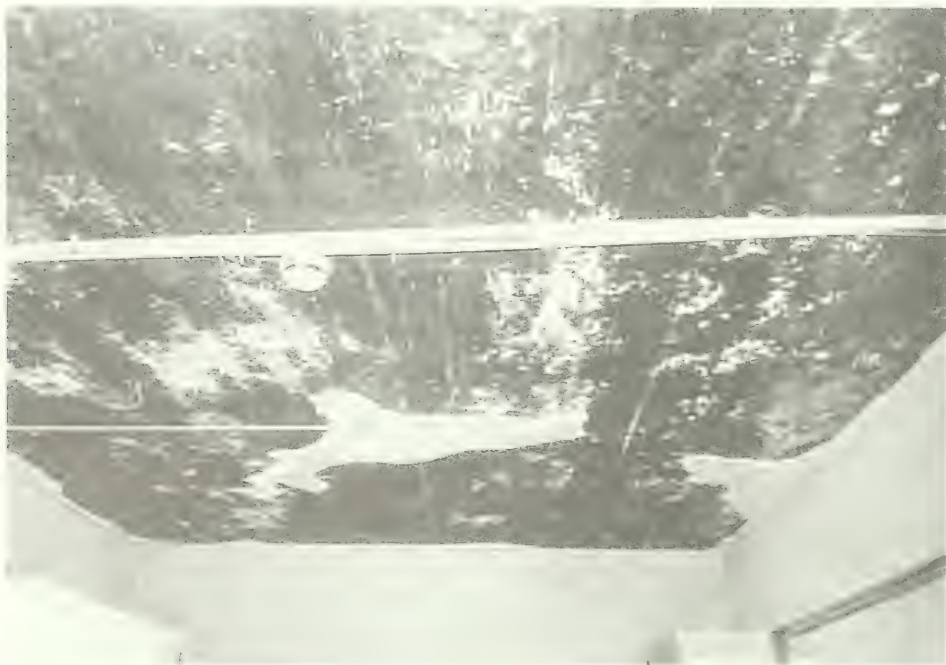
Photo 12: Annex, ceiling of Refrigerator Room.

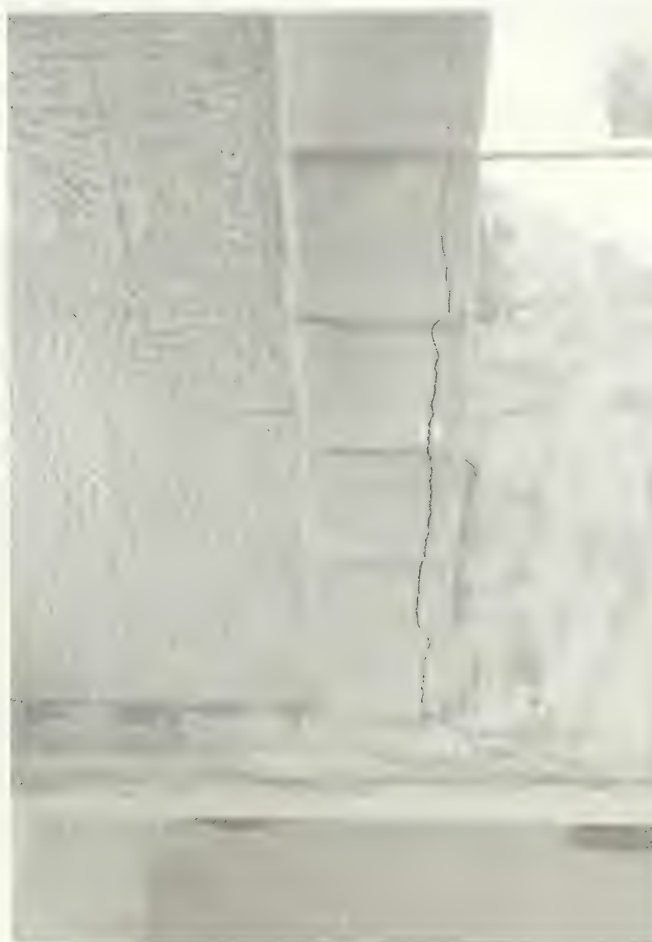
Photo 14: Bridge, looking north. Note longitudinal crack.

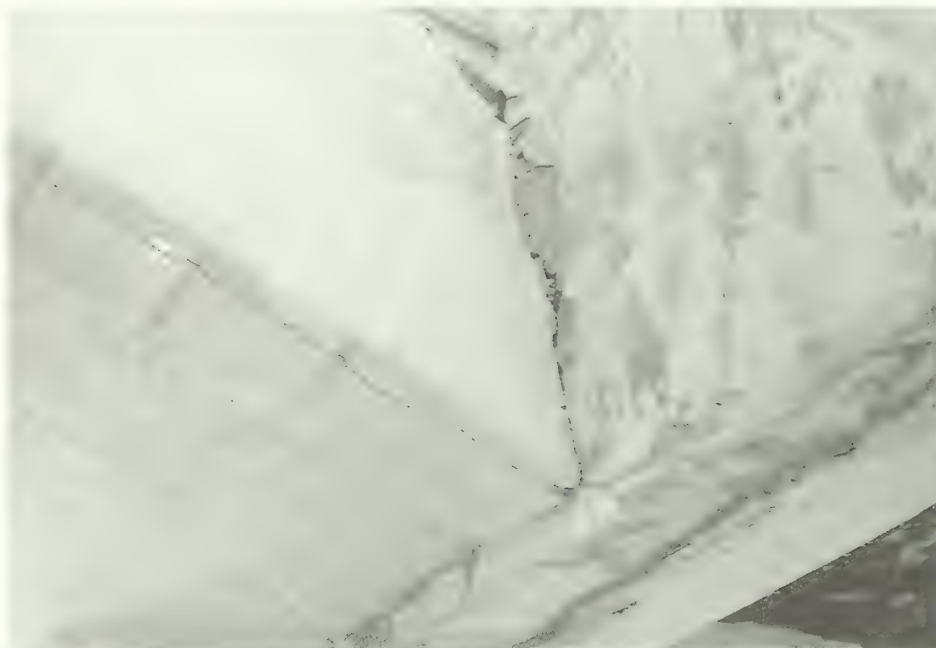
Photo 15: Bridge, looking west. Note stress cracks at connection with Annex.

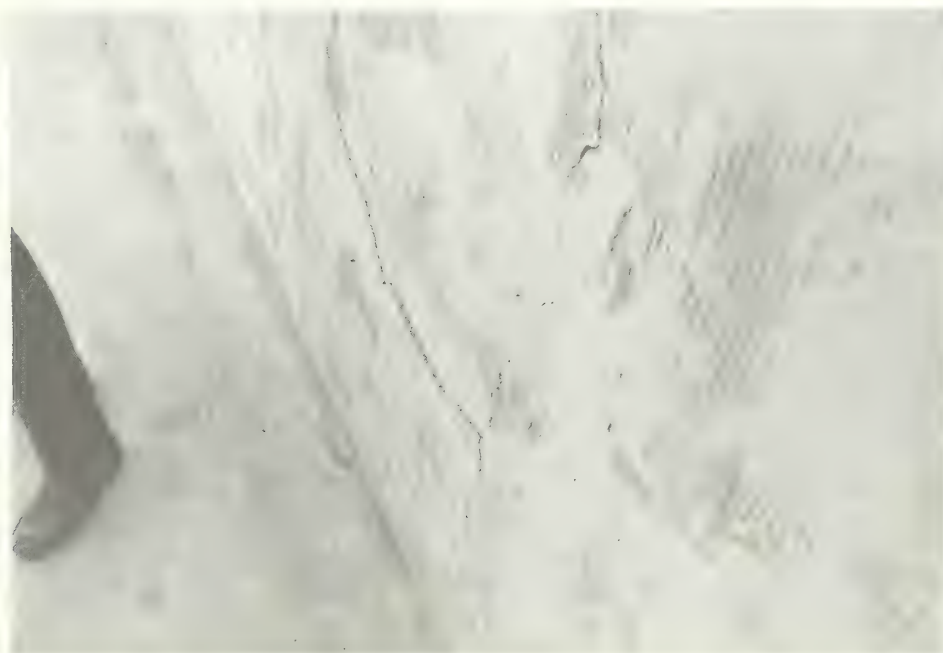
Photo 18: Annex north wall. Note cracking and bulging.

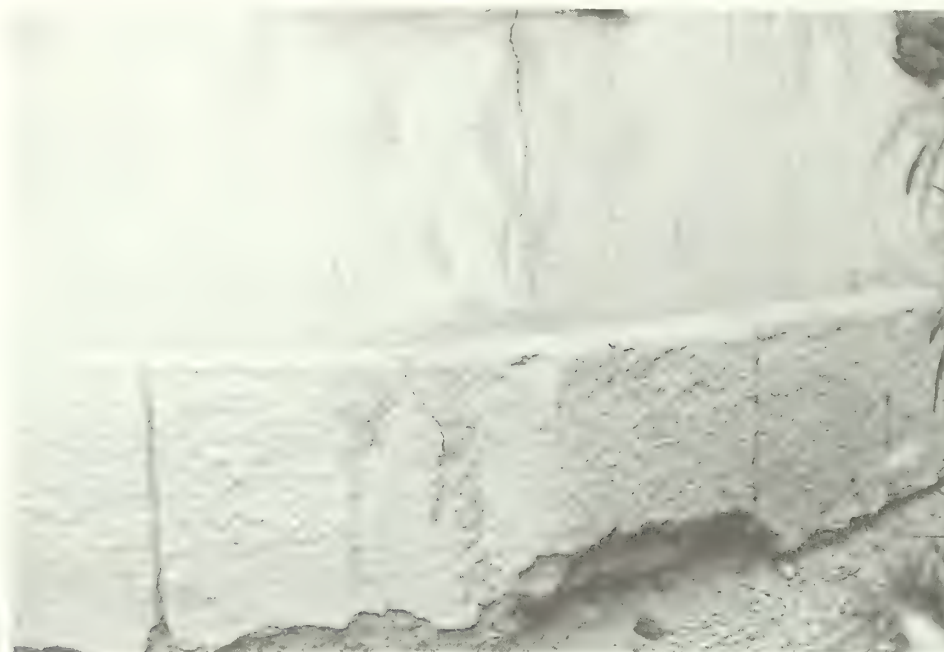
Photo 19: Main house, southeast corner. Note travertine eroding.

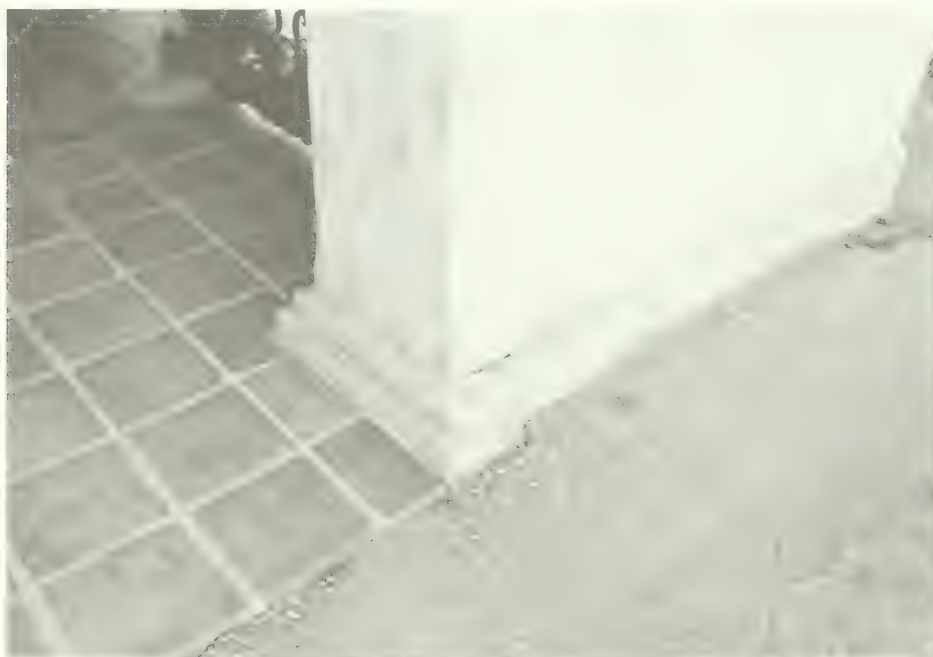
Photo 20: Main House, east porch. Note travertine at the base of the wall.

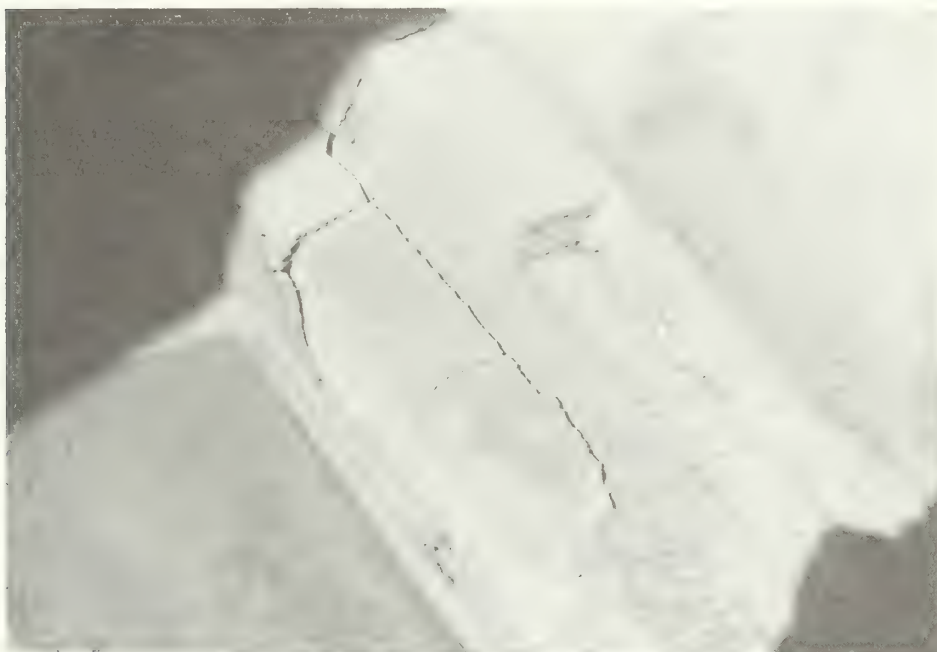
Photo 21: Main House, east porch. Note deteriorated travertine.

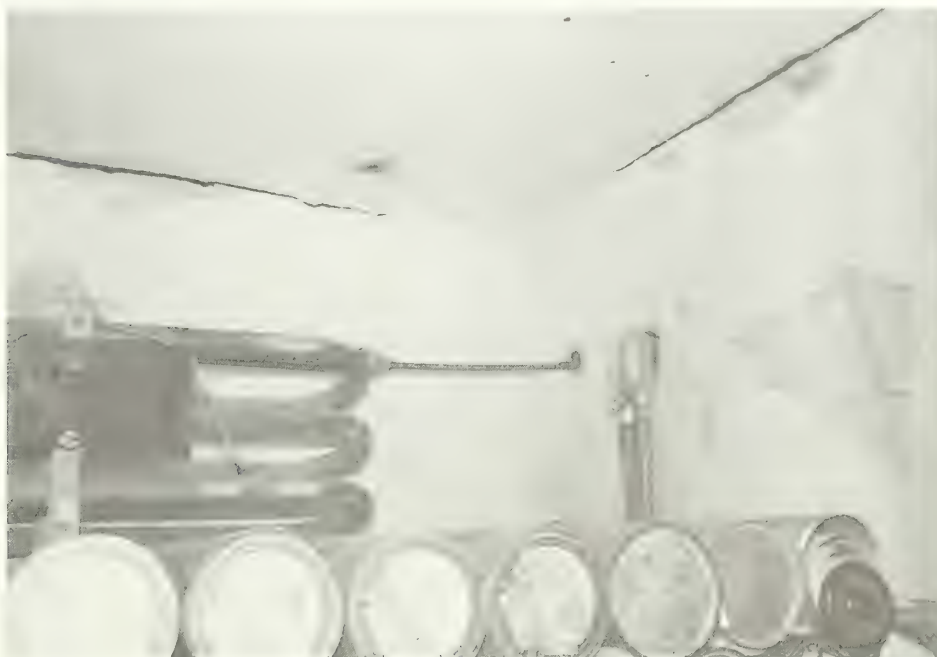
Photo 22: Annex, First floor refrigerator ceiling. Note water damage.

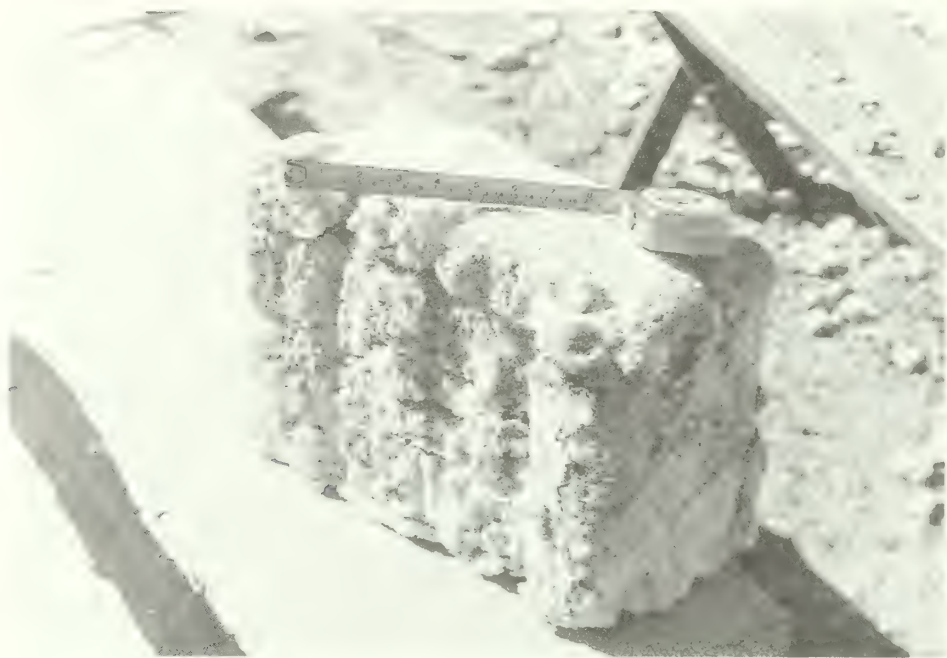
Photo 25: Main House, second floor window, southeast corner. Note crack in stucco at window sill and head.

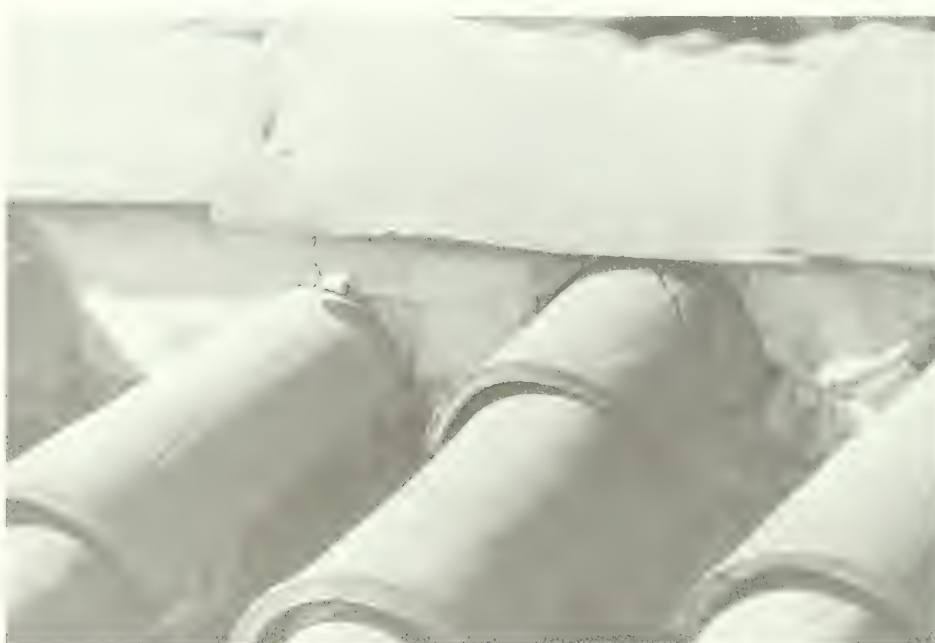
Photo 8: Roof tile detail, Main House. Portion of central ridge indicated above, showing cracked mortar and broken tile. Photo by R.L. Carper, April 1989.

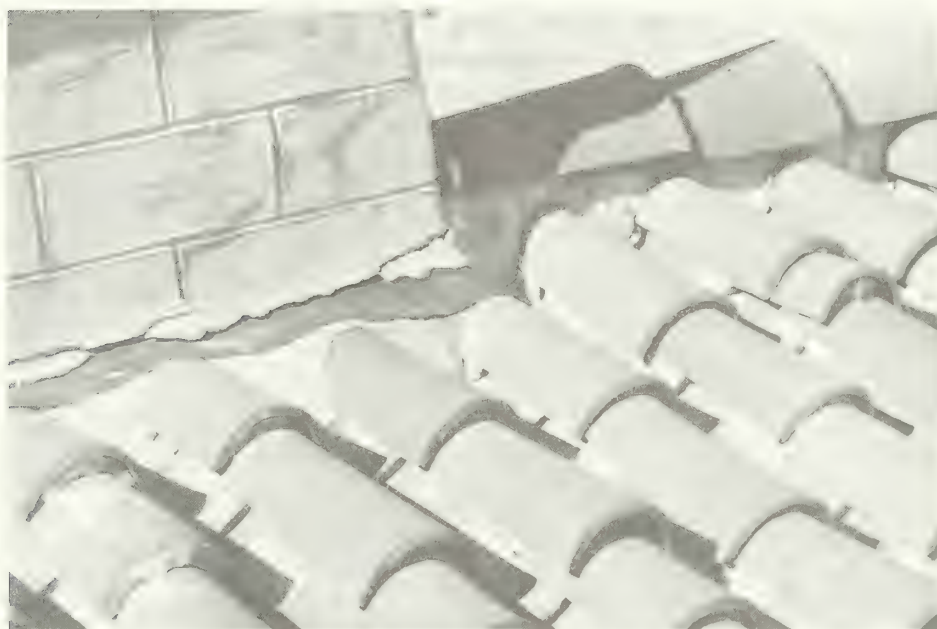
Photo 9: Main House roof, detail at base of east chimney, south side. Note mortar under ridge tiles, beneath chimney flashing and excess bedding mortar at individual tiles. Photo by R.L. Carper, April 1989.

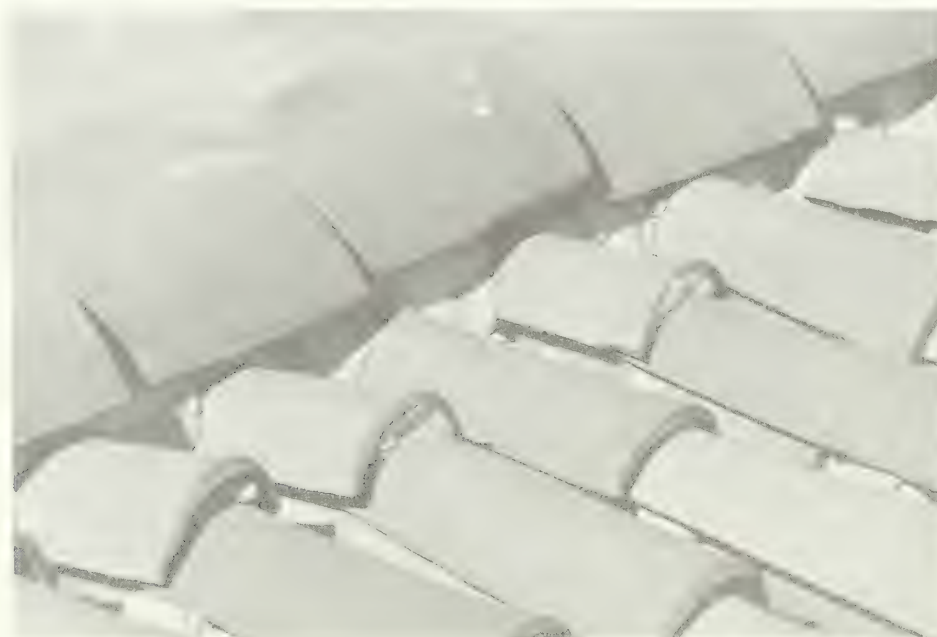
Photo 10: Roof tile detail, Main House, section of east ridge. Shows exposed bedding mortar and possible reverse-pitched tiles. Photo by R.L. Carper, April 1989.

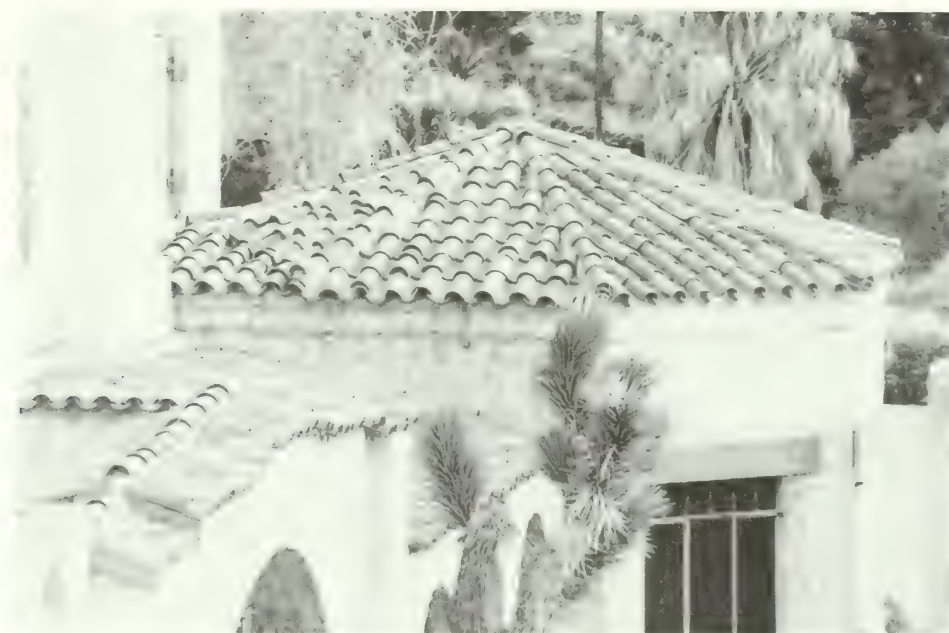
Photo 11: Solarium roof. Note missing tile on ridge adjacent to wall of Main House. Photo by R.L. Carper, April 1989.

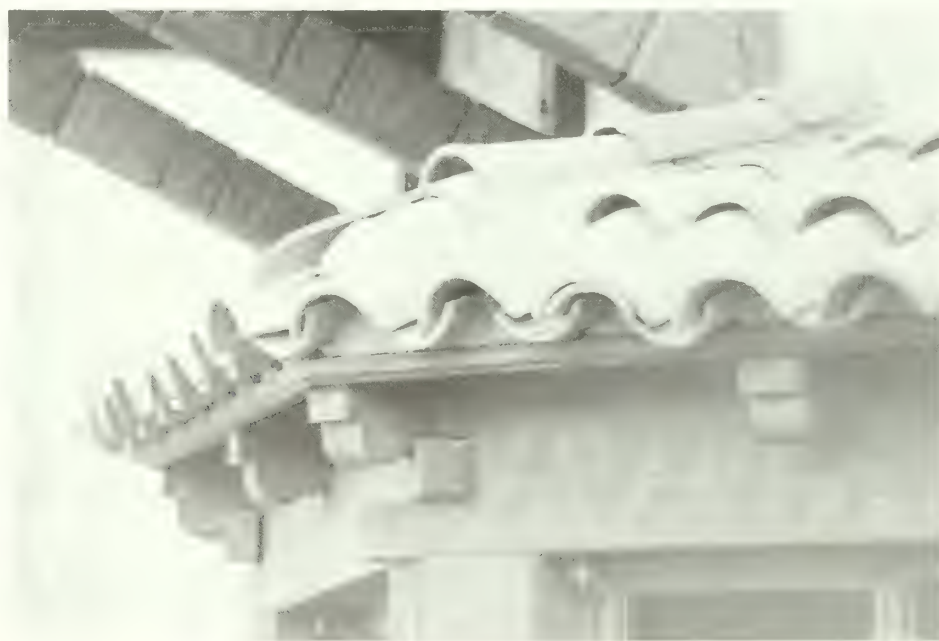
Photo 12: Dining Room bay, Main House. Shows missing and broken ridge tiles. Photo by R.L. Carper, April 1989.

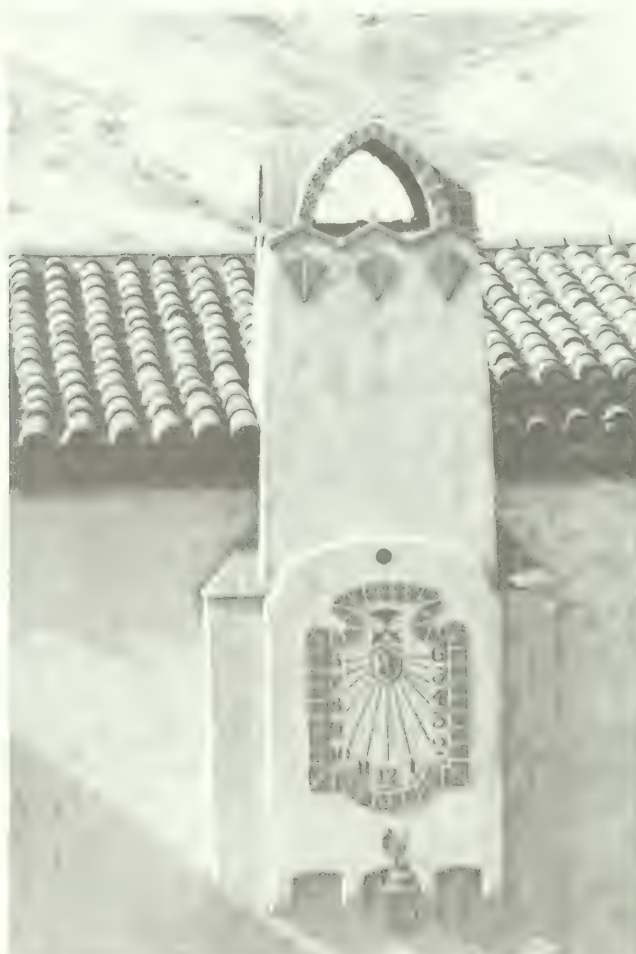
Photo 20: Annex; the chimney and sun dial at south wall of Upper Music Room. Illustrates the variety of types and uses of tile. Photo by R.L. Carper, April 1989.
